SOIL AND WATER CONSERVATION REVIEW IN ROMBO AND MONDABOGHO WATERSHEDS IN KAJIADO AND TAITA TAVETA COUNTIES, KENYA

Raphael M. Wambua

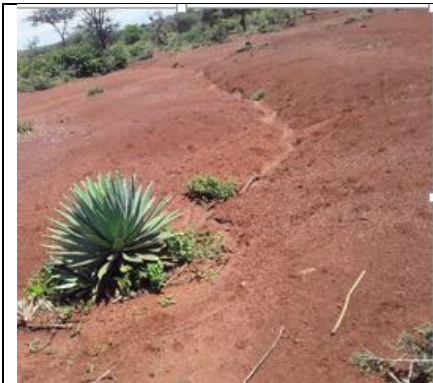
Figure 3: Sheet and rill erosion at Rombo watershed (Photo by Raphael M. Wambua)

Sheet erosion: in sheet erosion, top soil is usually eroded in layers leading to loss of soil fertility on the surface of land and thus low land productivity.

Rill and inter-rill erosion: Rill erosion refers to the detachment of soil particles on land forming shallow channels that can be removed by normal tillage operations. On the other hand inter-rill erosion is the detachment of particles from the areas that lie between the rills.

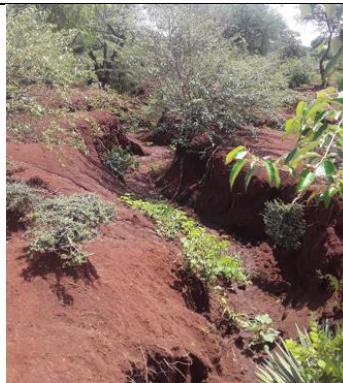
Figure 4: Gully erosion at the Rombo watershed (Photo by Raphael M. Wambua)

Gully erosion: gully erosion may be influenced by the interaction between the soil characteristics, channels, side walls, nature

of land including slopes and the seasonal precipitation parameters such as duration, distribution, quantity average and maximum intensity (Luffman and Nandi, 2020)

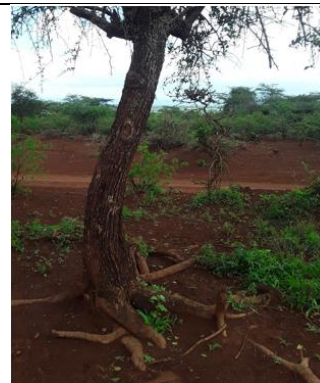
Figure 5: Exposed pant root system due to soil erosion (Photo by Raphael M. Wambua)

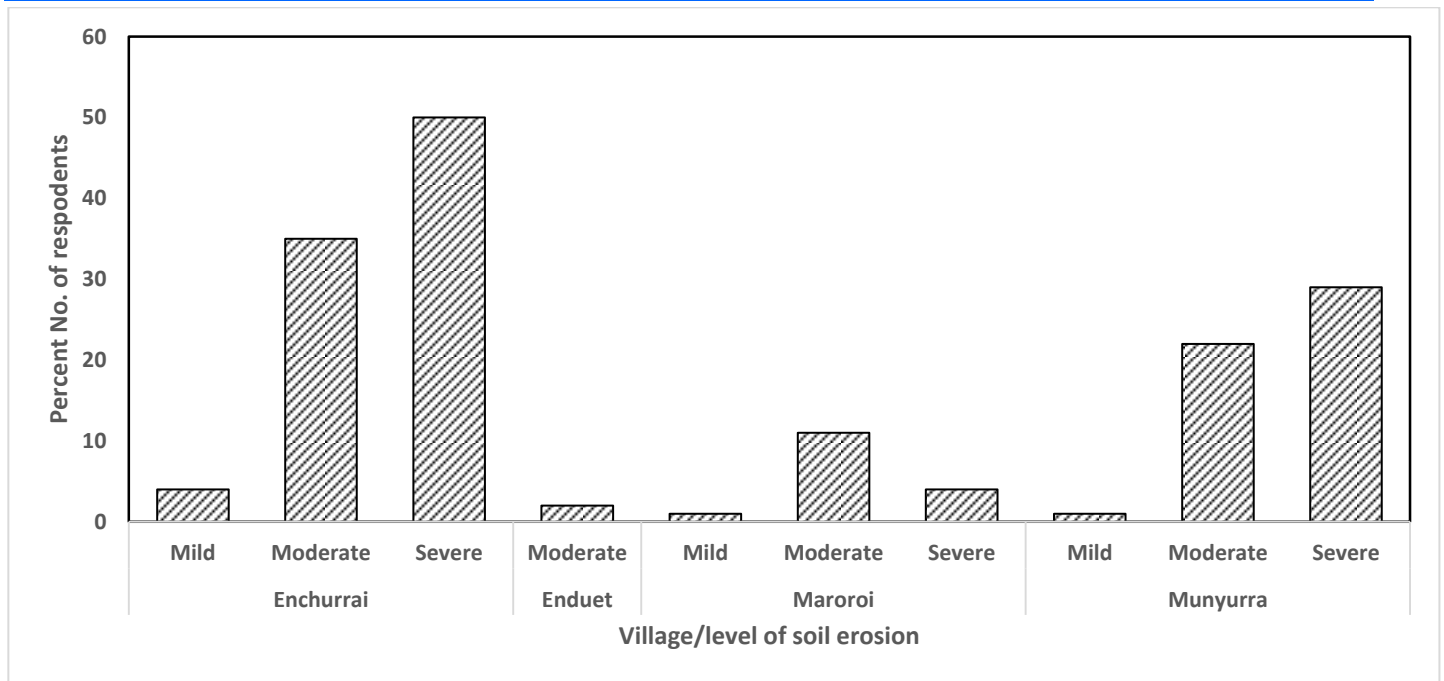
Figure 6. The level of soil erosion within the villages in Rombo watershed

- 50, 35, 5 percent of the respondents indicated that Enchurrai village experience –severe, moderate and mild soil erosion respectively
- 10, 4 and 2% of the respondents in Enduet village indicated that the area experience severe drought, moderate and mild soil erosion respectively
- 30, 25 and 2 percent of the respondents in Munyurra village experience severe, moderate and mild soil erosion respectively

The results show that Enchurrai village is the most affected in Rombo watershed by soil erosion followed by Munyurra, Maroroi and

Enduet villages in that order. This ranking is key for prioritized soil and water conservation since it shows that any strategies to conserve soil and water on agricultural fields should be begun by Enchurrai village followed by the others in the same order.

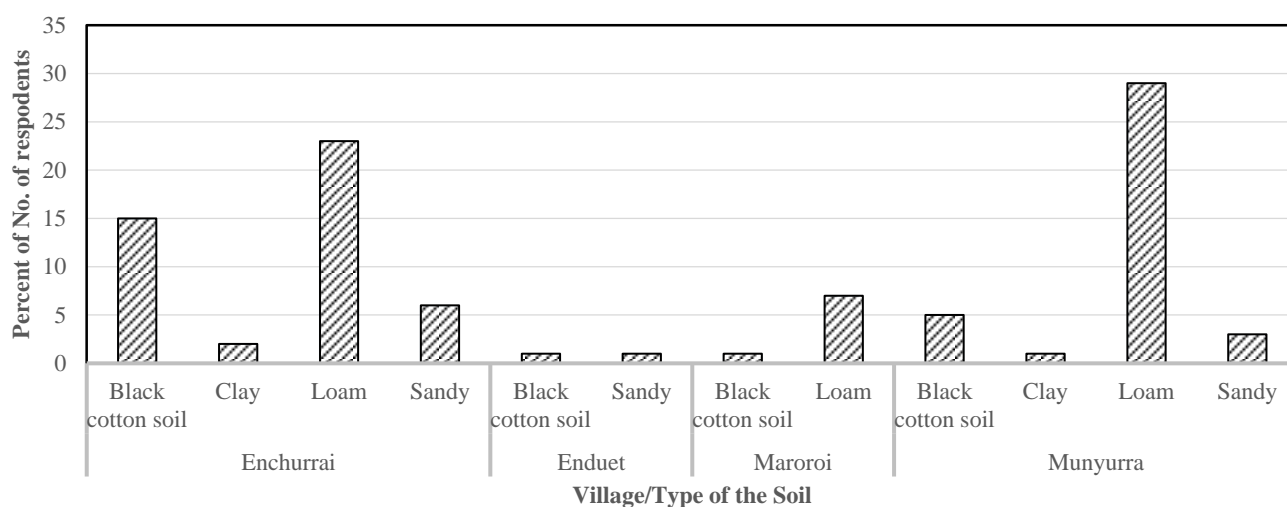
Figure 7. Distribution of soil types across the villages in the Rombo watershed

From the above data 15, 3, 23 and 6 percent of the respondents indicated that their soil is black cotton, clay, loam and sandy soils respectively. It was also observed that 2 percent of the respondents in Enduet village showed that the soil is both black cotton and Sandy soils. Additionally, 2, 7 percent of respondents in Maroroi Village indicated black cotton and loam soils respectively. 5, 2, 28, and 3 percent of respondents in Munyurra indicated black cotton, clay, loam and sandy soils respectively.

It was found that the dominant soil type for Enchurrai, Maroroi and Munyurra villages was Loam soils. The other soils occurring within these three villages are black cotton, clay and sandy in different proportions. Enduet village had two main types of soil; black cotton and sandy soils almost equally

distributed. The soil types influence the soil erodibility factor. For instance the soil erodibility factor K values for sand, loam and clay soils may range from 0.05 to 0.2, 0.025 to 0.4 and 0.05 to 0.15 based on English units.

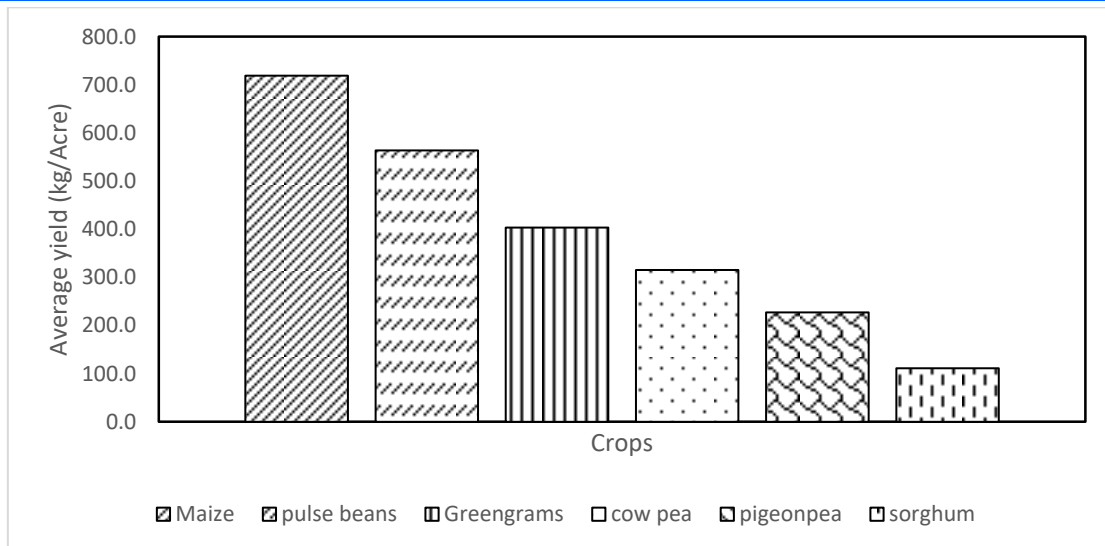
Figure 9. Average grain yield for common crops grown in Rombo watershed

The results indicate that the average yield for the study area was 719, 563, 404, 316, 227 and 111 kg/acre for maize, pulse beans, green grams, cow pea, pigeon pea and sorghum respectively. This is quite low compared to optimum expected yields for these respective crops in ASALs. The low

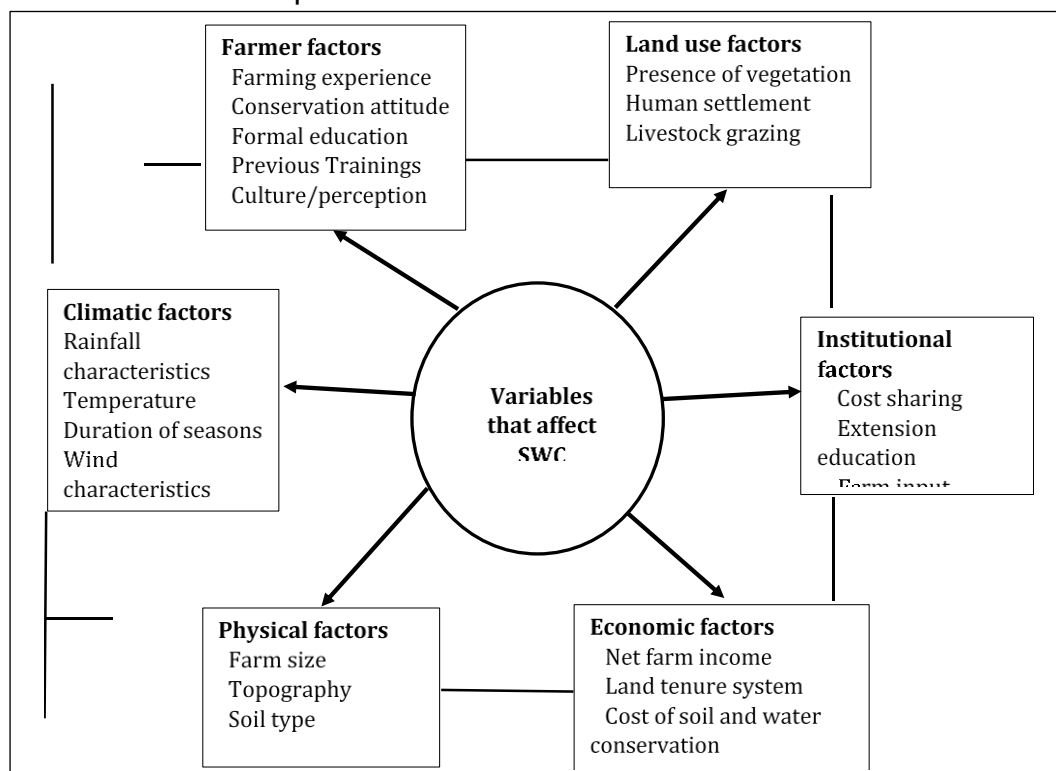
Figure 10. Variables that affect SWC practices in farms located in Rombo and Mondabogho watersheds

production is attributed to on-site soil erosion among farm factors that are shown in Figure 10.

Farmers were also aware of factors that determine SWC practices, ranging from farmer characteristics, land use, climatic, institutional, physical and economic. These factors are critical in considering adoption of SWC structures and its sustainability. It was found that these watersheds do not have adequate SWC structures and that the few that are in existence have been constructed manually.
